Archeological area of Sant'Eulalia

Patrimonio culturale
SARDEGNA Virtual Archaeology

■ Second collapse

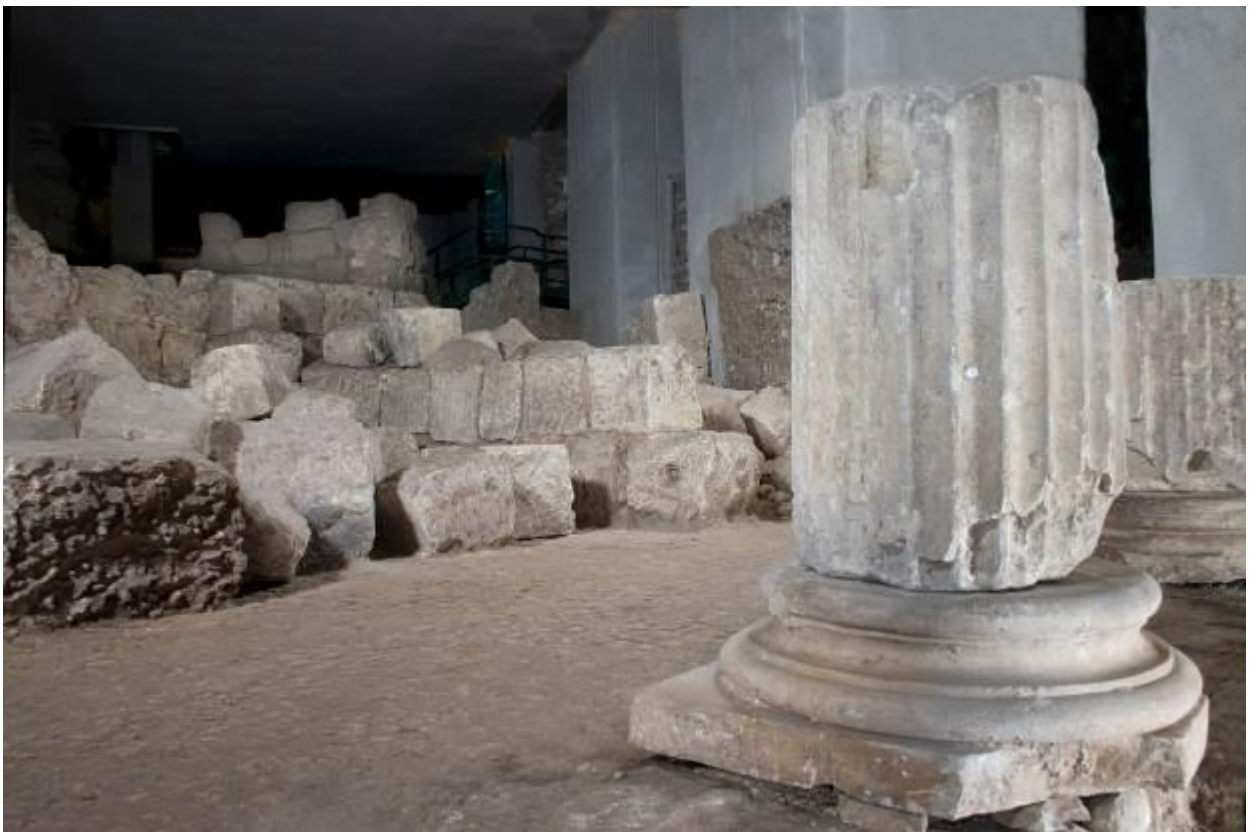
Fig. 1 - View of the portico with the second collapse *in situ* (photo by AFS).

A second collapse landed on the environment created with construction of the transversal structure inside the portico.¹, filling the building materials already arranged into parallel rows and making the colonnade itself useless, at an unspecified moment and because of unknown events (fig. 1).

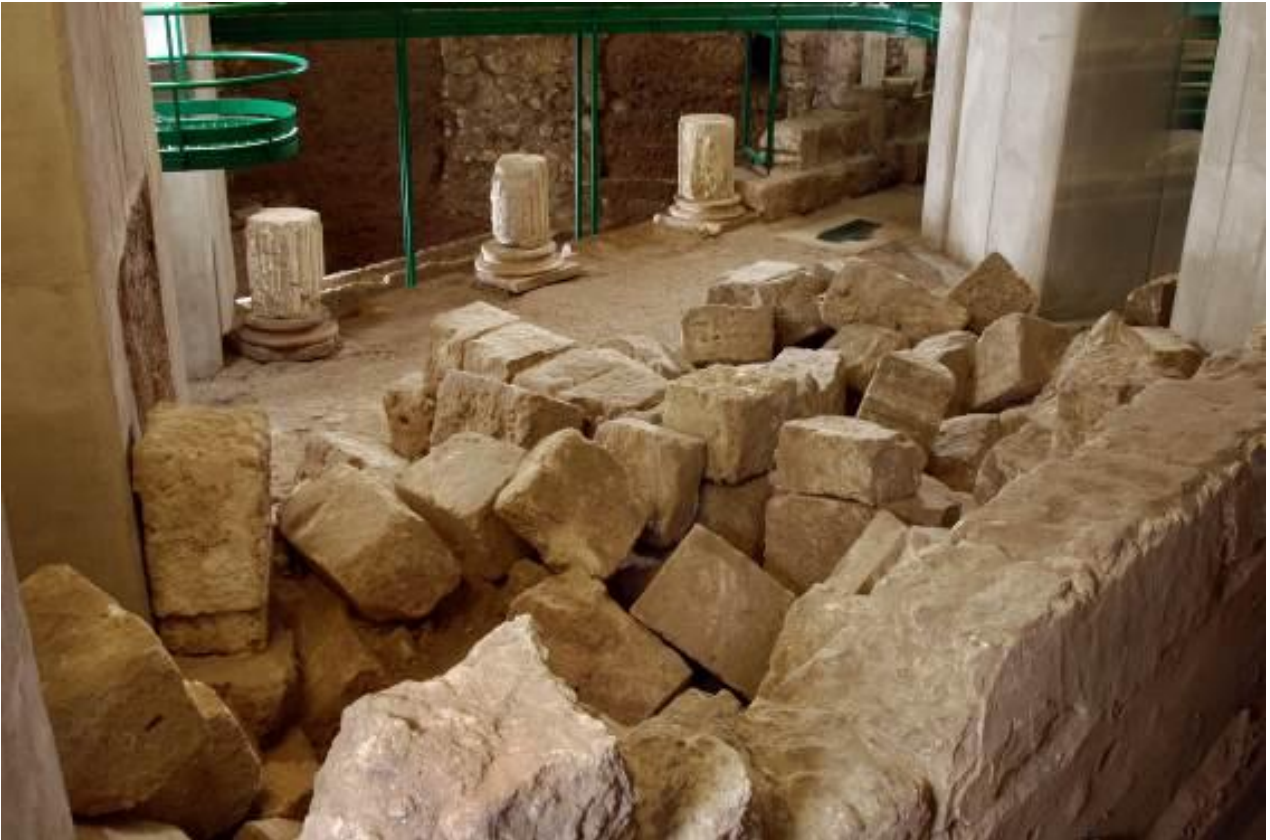
Fig. 2 - Second collapse seen from behind the portico (photo by AFS).

the erection of a new building, after it had been abandoned for a long period. These changes modified the area's urban structure. The limestone blocks related to the collapsed structure were left *in situ* (figs. 2-4) to document the reconstruction hypotheses of scholars, who suggested interpreting it as a natural collapse or intentional dismantling for reuse.

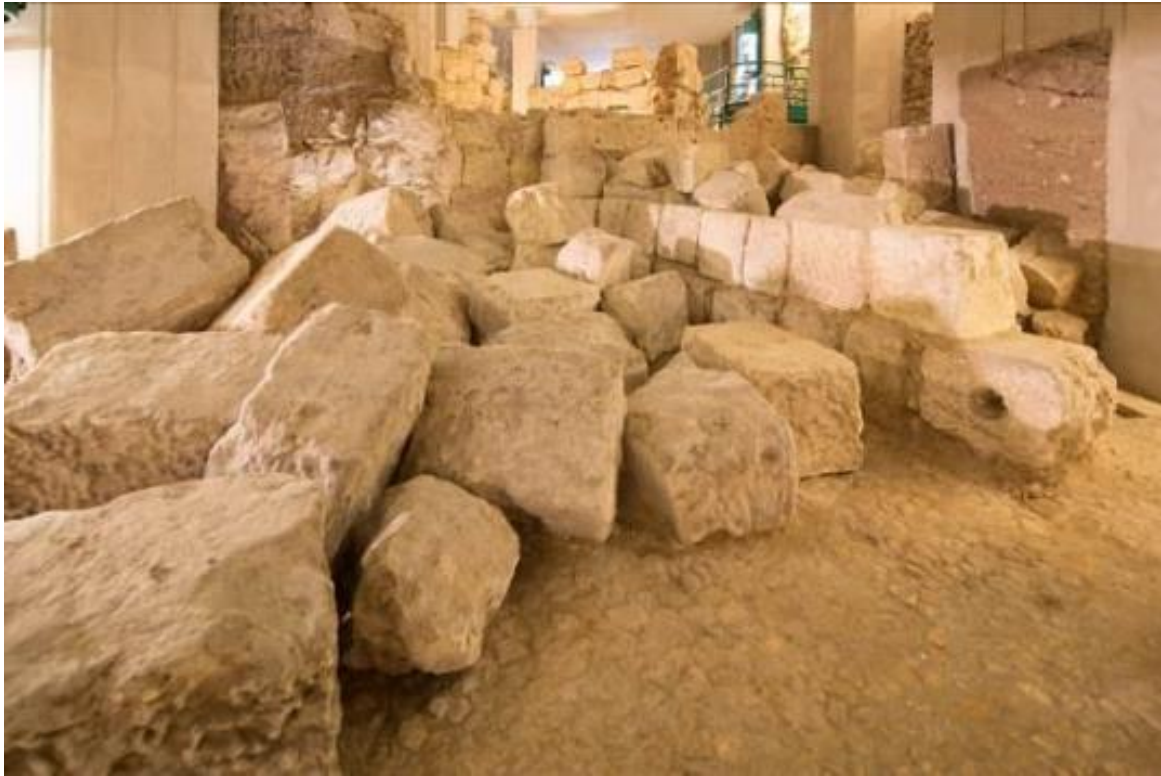
Fig. 3 - Blocks collapsed to the left of the transversal wall in the portico (photo by Unicity S.p.A.).

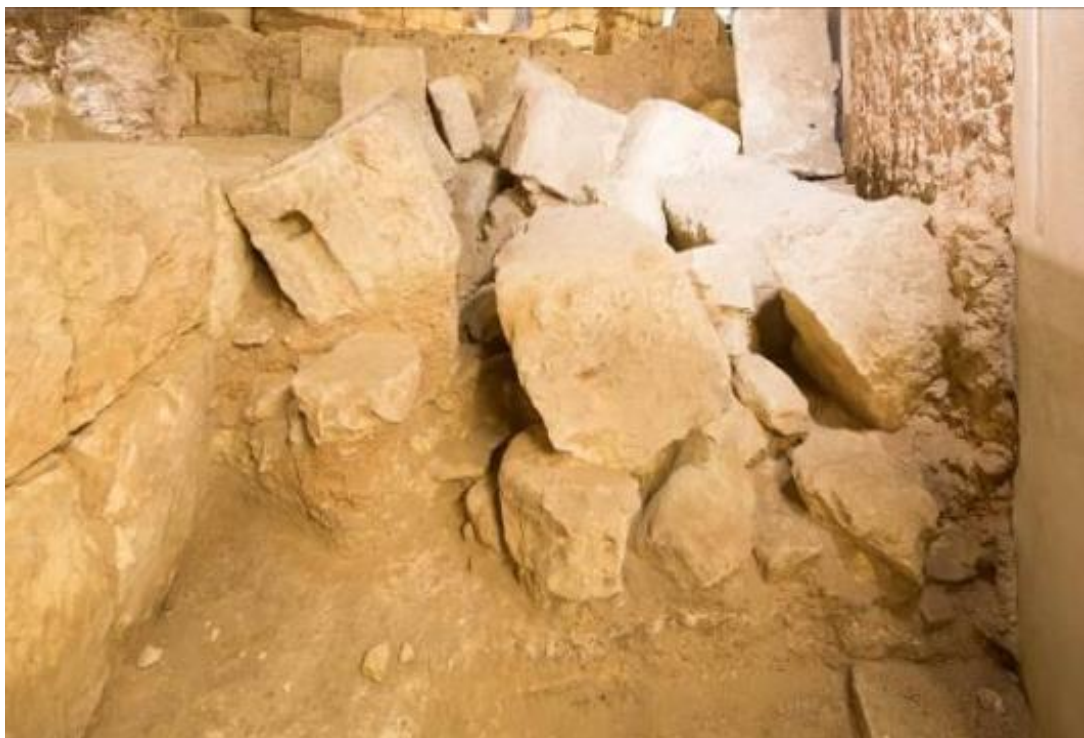
Fig. 4 - Blocks related to the II collapse on the left side of the transversal wall, standing on a layer of the previous collapse (photo by Unicity S.p.A.).
