Archaeological area of Tharros

Patrimonio culturale
SARDEGNA Virtual Archaeology

■ The thermal baths nr. 1

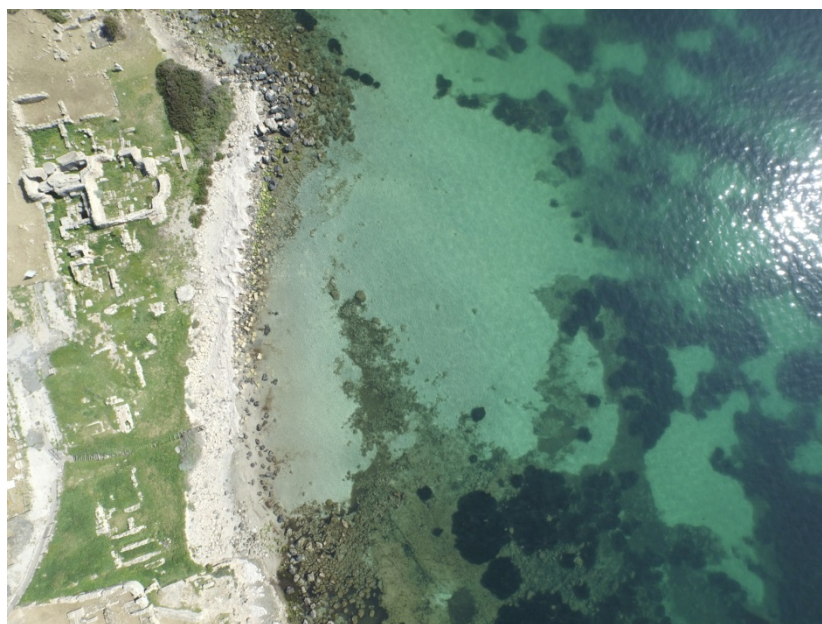
Fig. 2 - Thermal baths nr. 1 (photo by Unicity S.p.A.)

This thermal baths building, called thus as it was the first to be investigated in the Tharros area, stood overlooking the Gulf of Oristano coastline, on the north-east edge of the public area of the city (figs. 1-2).

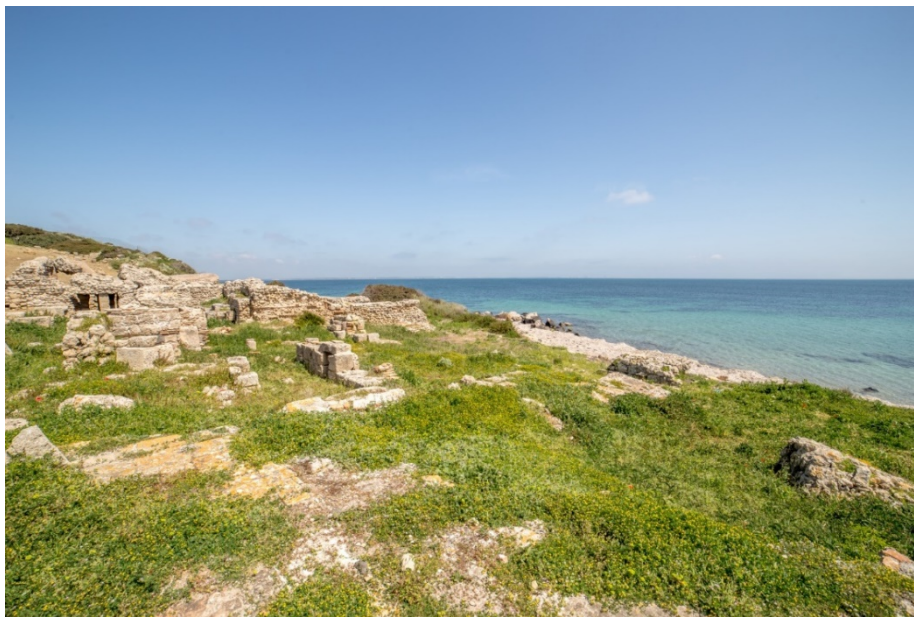
Fig. 4 - Thermal baths nr. 1 from the south (photo by Unicity S.p.A.)

The thermal baths are thought to have been built in the 2nd century A.D. (figs. 4-8).

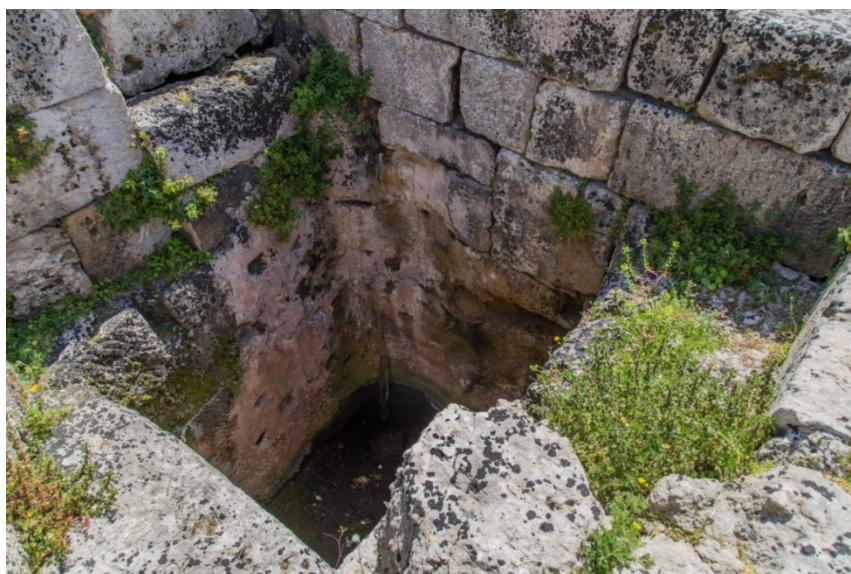
Fig. 5 - Detail of the Large cisterns for Thermal baths nr. 1 (photo by Unicity S.p.A.).

An *apodyterium* (1) was accessed from the road, which, during the dig, still contained fragments of flooring; the *frigidarium* has been completely lost, but it was likely placed in the northern part of the building, where the remains of the large cisterns remain, that probably feed the tubs for cold baths.

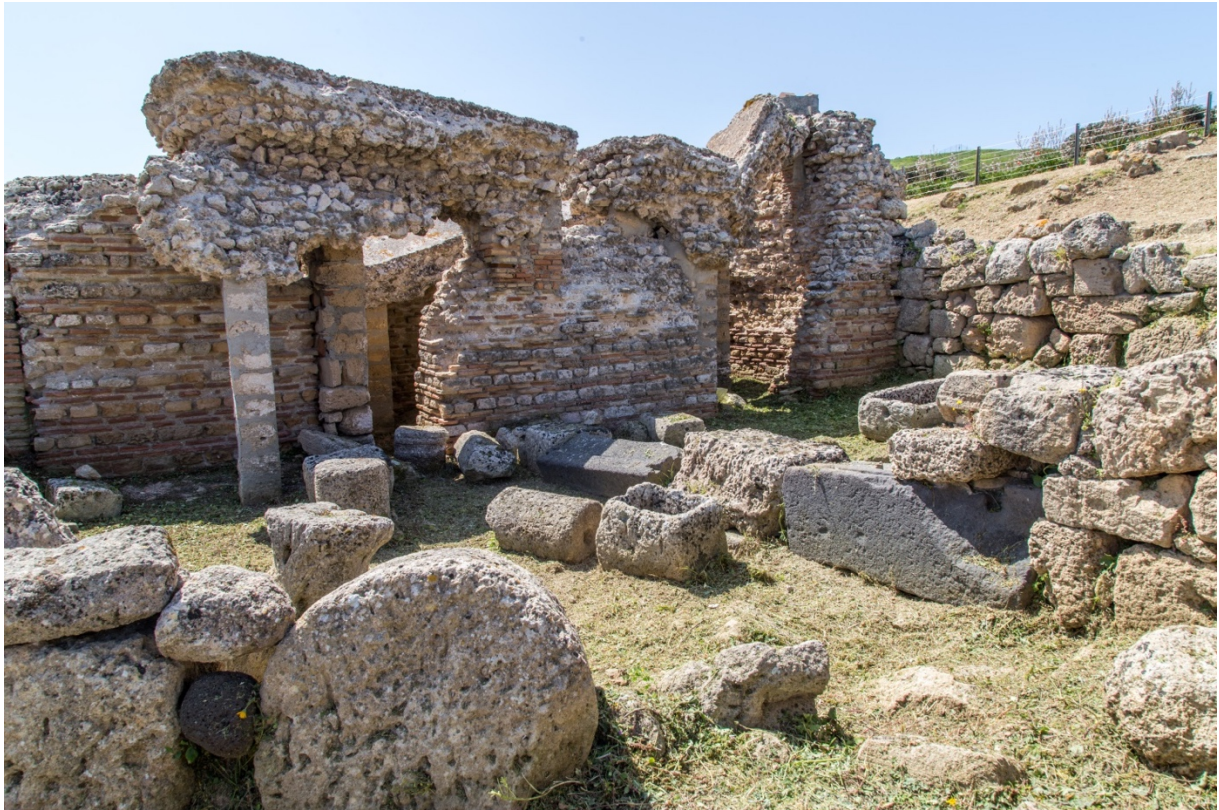
Fig. 6 - The northern *calidarium* transformed into a cemetery (photo by Unicity S.p.A.)

The building was dismantled in a late period and re-adapted for other uses. Room 3 and adjacent ones were partly transformed into a cemetery and partly perhaps connected to a PaleoChristian place of worship that was built immediately to the north. The dates taken from the few items in graves indicate the Vandal and Byzantine Ages.

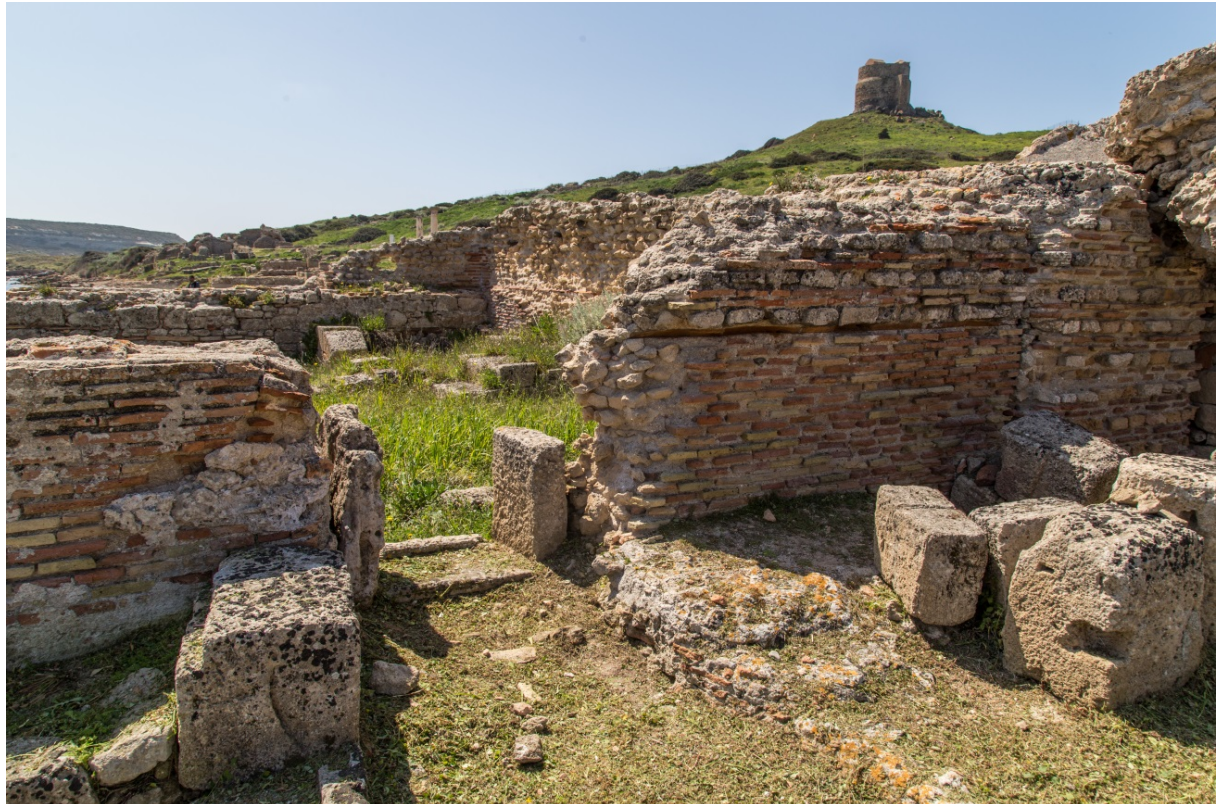
Fig. 7 - The entrance to the northern *calidarium* opened in the Vandal era (photo by Unicity S.p.A.)

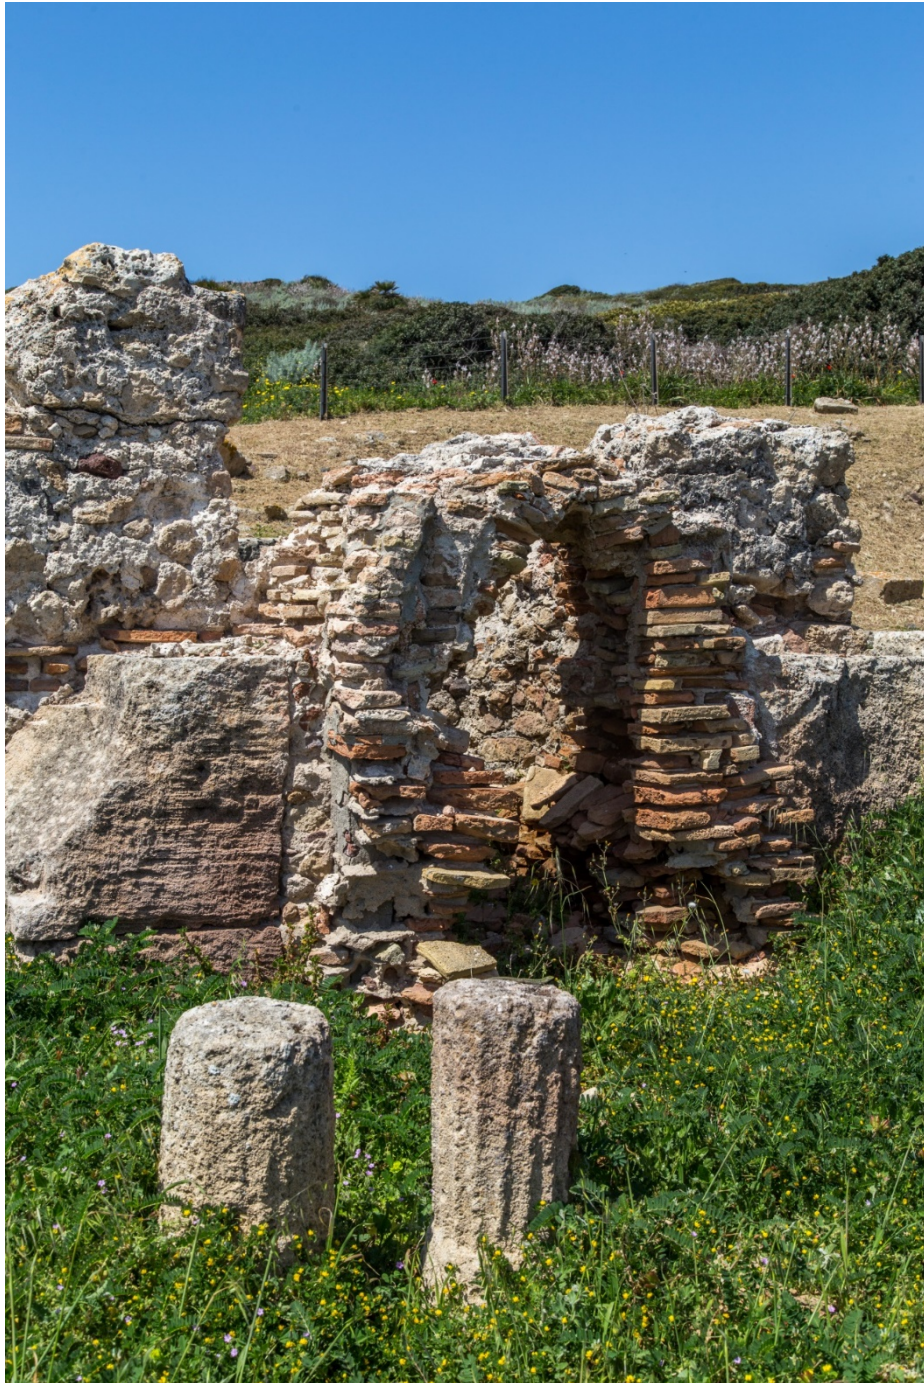
Fig. 8 - Remains of a *praefurnium* (photo by Unicity S.p.A.)

The heated room shown with the number 3 on the map shows an apse on the eastern side that probably contained a *labrum* for cooling down; on the northern side there is still a *praefurnium*.
